Landslides (2018) 15:199–217  
DOI 10.1007/s10346-017-0865-0

R. Tomás · A. Abellán · M. Cano · A. Riquelme · A. J. Tenza-Abril · F. Baeza-Brotons · J. M. Saval · M. Jaboyedoff

## A multidisciplinary approach for the investigation of a rock spreading on an urban slope

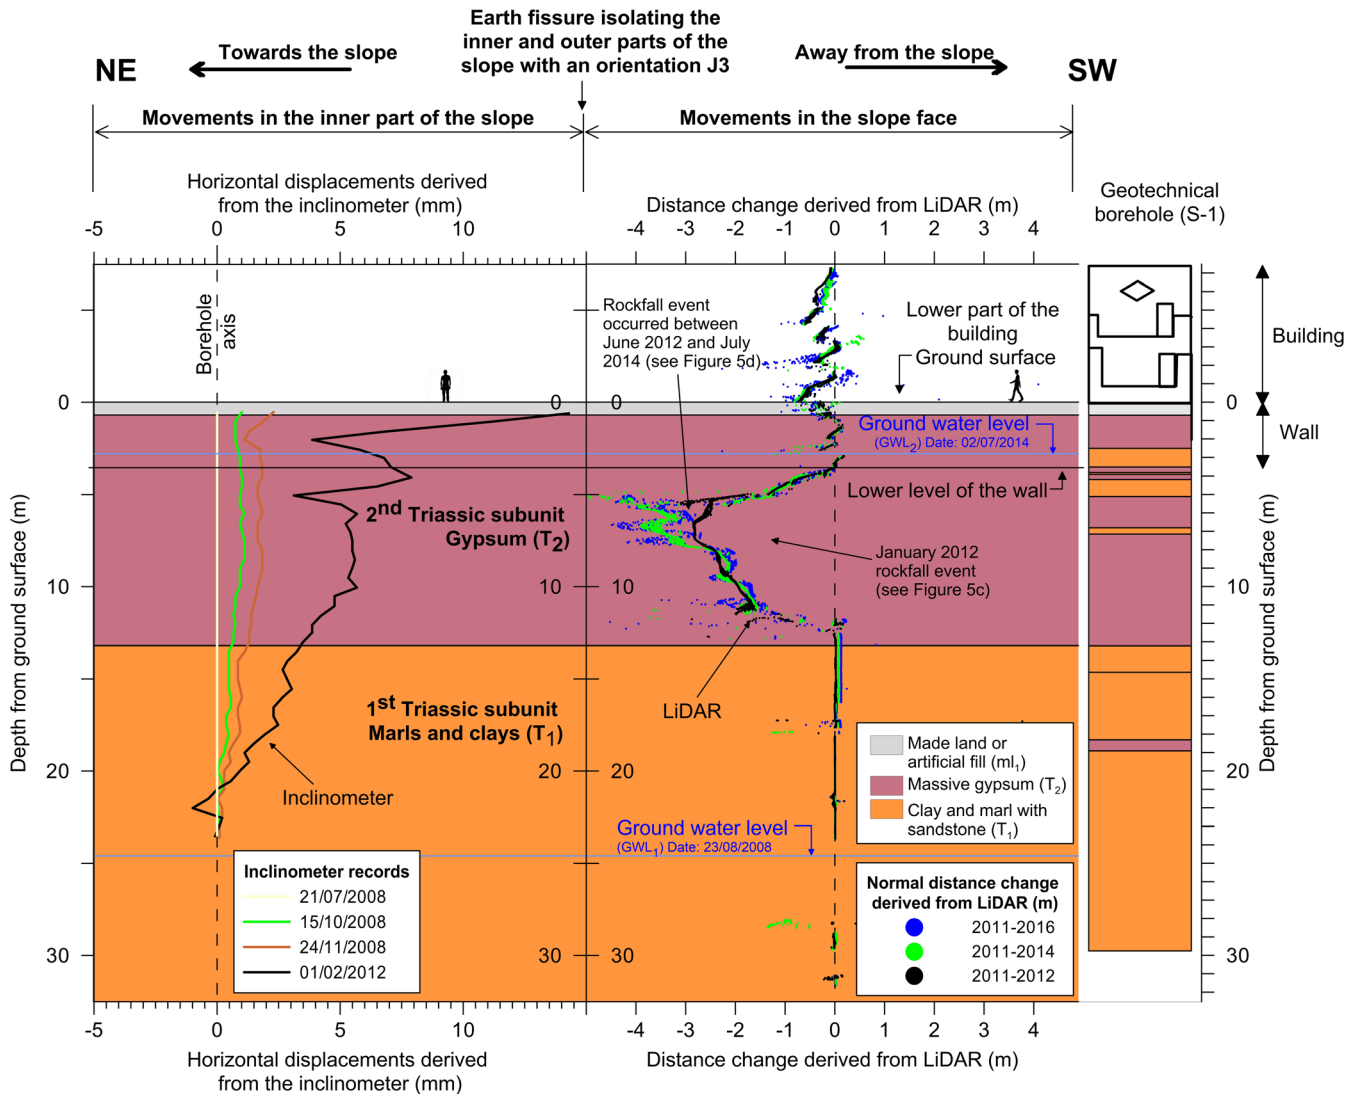
The inclinometer installed in geotechnical borehole S-1 (Figs. 1 and 3) shows maximum horizontal displacements in the slope face direction near 15 mm between July 2008 and February 2012 on the more surficial layers (from 0 to 5 m depth). The horizontal displacements

gradually reduce from 5 up to 21 m depth, being consistent with toppling failure. The available records appear to indicate that the inclinometer is not sufficiently deep to reveal in detail the bottom of the moving region. In the direction parallel to the slope, the displacements are lower than 2 mm and gradually decrease with depth. The independent measurements performed between April 2012 and May 2014 considering a new time origin provided maximum horizontal displacements near 6 and 4 mm in the dip direction and the parallel directions of the slope, respectively.

**Fig. 3** LiDAR and inclinometer records and S-1 geotechnical borehole log. The section is placed across the building ranked as a Class 6 (partial collapse) in Fig. 10

As previously mentioned, inclinometer S-1, which is 7 m from the slope face (Fig. 1), showed maximum horizontal internal displacements on the more surficial layers of the slope, gradually reducing with depth (Fig. 3). On the other hand, the TLS data

2012 event was located in the depth range in which maximum horizontal displacements up to 8 mm were measured between July 2008 and February 2012 by means of the inclinometer (Fig. 3). Furthermore, this sector of the slope presents the maximum small-scale displacements (near 20 cm) derived from LiDAR between 2011 and 2014 (Fig. 6). Therefore, it seems that the recorded rockfalls are exacerbated by the larger failure observed by the inclinometer and the LiDAR.

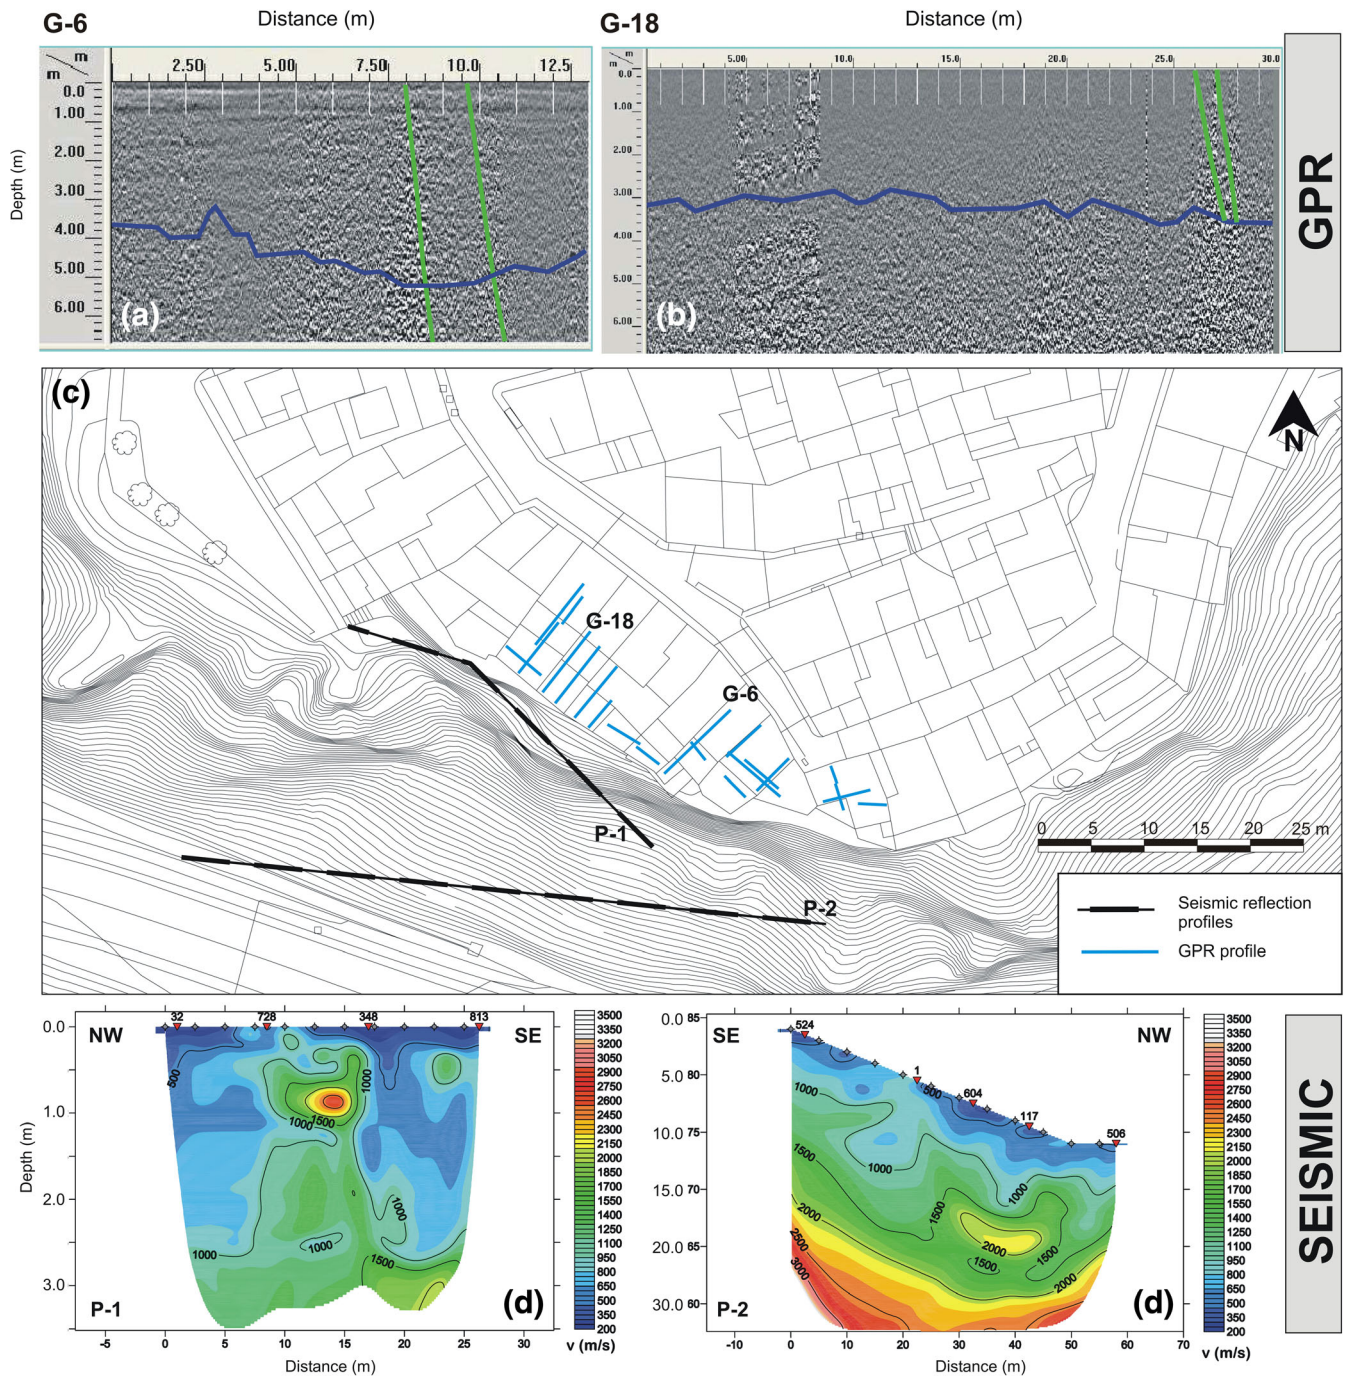
GPR continuous graphic profiles were recorded using a GSSI SIR-20 data acquisition system coupled to an antenna with a frequency of 200 MHz. The profiles were conducted on 16 linear sections located on the ground floor of the damaged buildings located on the crown of the slope (i.e. on the top of the massive gypsum subunit,  $T_2$ ) and post-processed to enable the interpretation of the existing features. The depth of the GPR survey covers the upper 6 m of depth as the main aim was to locate the earth fissures affecting the more surficial layers. The results show that the depth of the less stiff materials (i.e. artificial filling,  $ml_1$ , and weathered massive gypsum) reaches depths from 1.5 to 5.0 m (Fig. 4). Moreover, the GPR profiles have allowed the recognition of different earth fissures with depths varying from 2 to 4 m. The depth of these cracks reaches maximum values near profile G-6 of 4 m gradually decreasing towards the eastern and western ends.

Furthermore, the correlation of the different GPR profiles has allowed delineation of the direction of the main earth fissure affecting the buildings that varies from N109E to N130E.

**Fig. 4** a, b G-6 and G-18 ground penetrating radar profiles. Blue lines represent the top of the massive gypsum subunit (T2) and green lines the earth fissures. c Location of the ground penetrating radar and seismic refraction profiles. Note that although the figure represents the 16 GPR transects performed, only profiles G-6 and G-18 are shown as examples. d, e Seismic refraction profiles made on and along the slope. Notice that the vertical and horizontal scales of P-1 and P-2 profiles are different in both plots

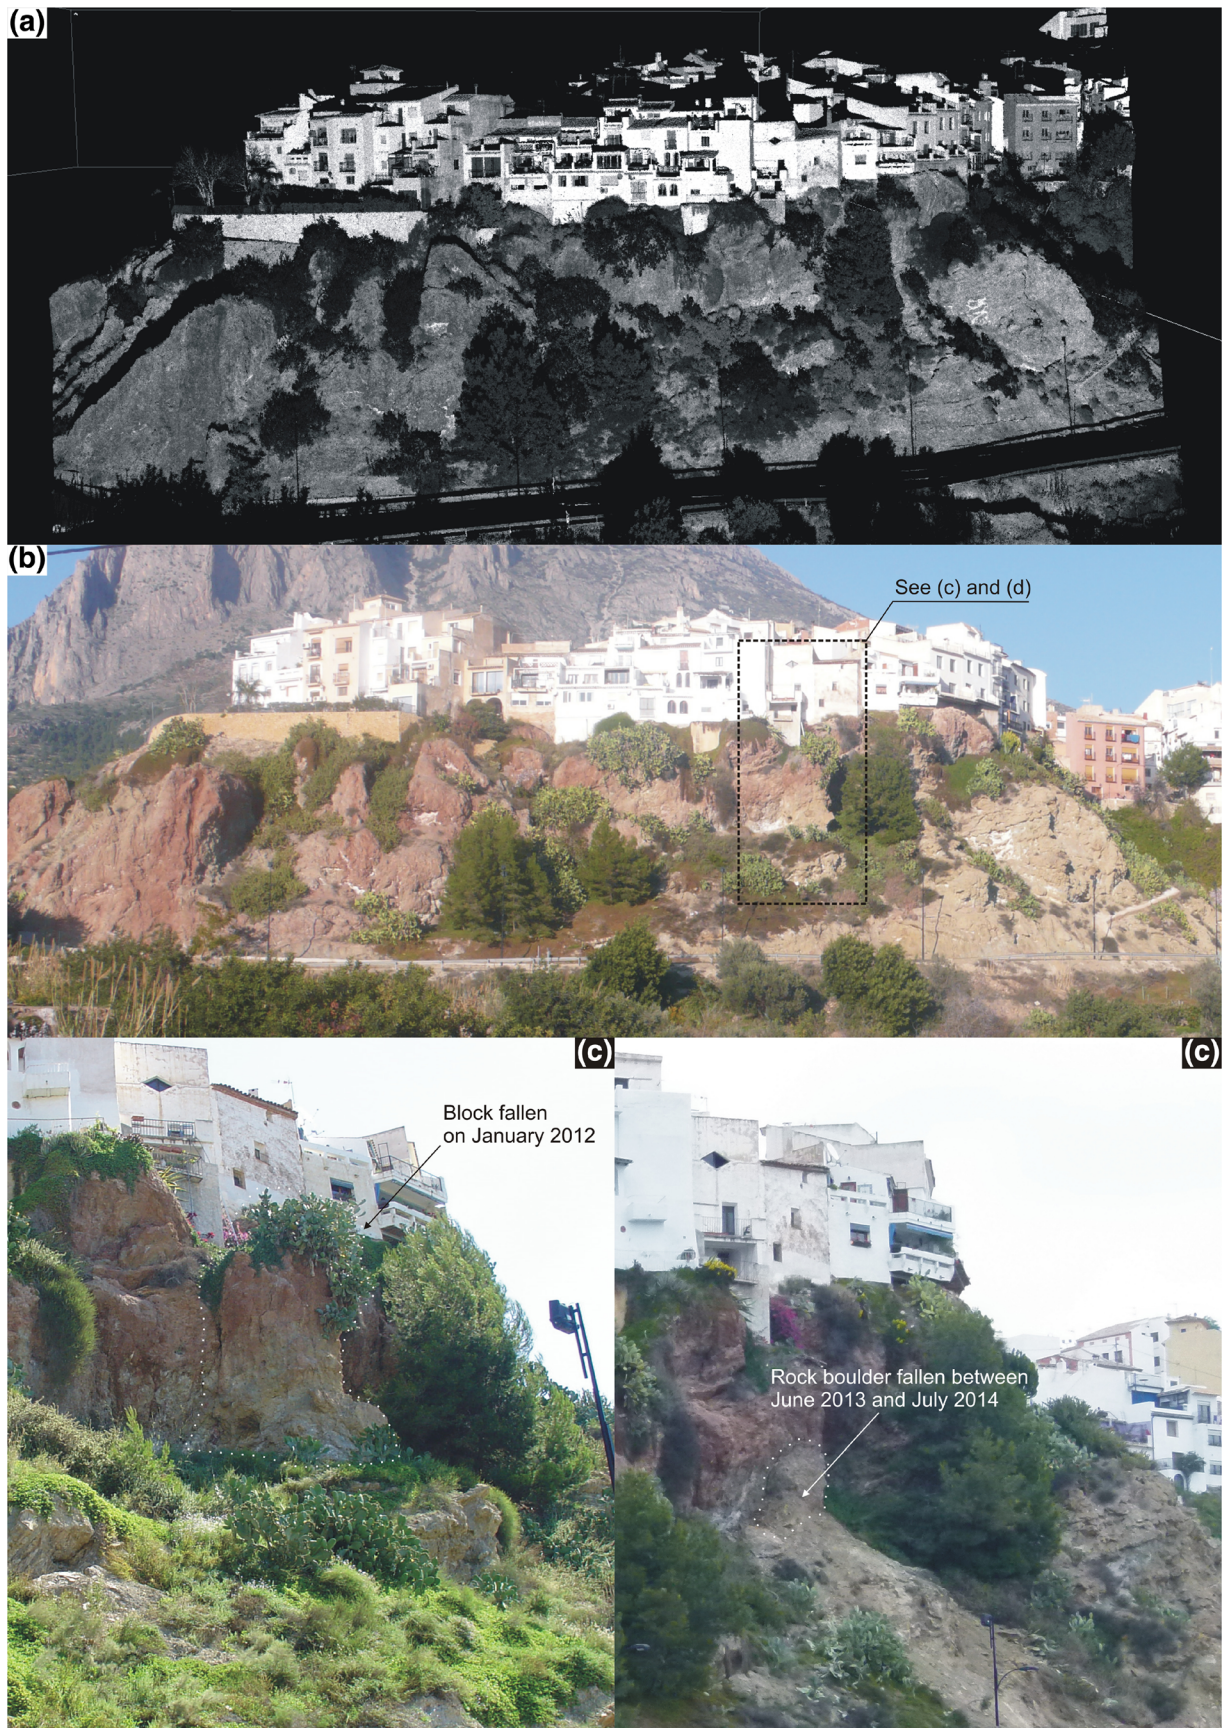
The slope has historically exhibited some slope instabilities, including the recent occurrence of the 60 m<sup>3</sup> event that happened during January 2012 and a minor rockfall event occurred between June 2013 and July 2014 (Figs. 1 and 5). Coetaneously, some buildings founded near the cliff were severely damaged due to a slow-moving lateral spreading, causing considerable social alarm in the local population. The lithological, structural and geomorphological information acquired in this study suggests that there is an important structural and lithological control of the observed instabilities. Indeed, the co-existence of Triassic weak and brittle massive gypsum (T<sub>2</sub>) laying over less competent lithologies (i.e. marls and clays from T<sub>1</sub> subunit) (Fig. 11) controls the generation of slope instabilities. This type of landslide typically develops on slopes formed by a soft and ductile material capped by a fragile rock mass (e.g. Elorza and Gutiérrez Santolalla 1998, Gutiérrez-Santolalla et al. 2012, Gutiérrez et al. 2012, Mantovani, et al. 2013). Additionally, the delimitation of the massive gypsum blocks by subvertical crack J<sub>3</sub> that presents an orientation 18/79, parallel to the free face of the slope (Fig. 9), facilitates the mobilization of portions of massive evaporitic rock over the less competent lithologies, following an undefined basal shear surface. Similar behaviour has been pointed out in analogous study areas before (Gutiérrez, et al. 2012, Mantovani, et al. 2013, Pasuto and Soldati 2013). Therefore, the geomorphological, lithological and structural evidences point to the existence of a rock spreading landslide, which has been amplified by the loss of lateral support due to recent rockfall occurrence.

**Fig. 5** a 3D point cloud acquired in the February 2011 LiDAR survey. b General view of the scanned area (February 2011). c Rock blocks destabilized in January 2012 and d during the period 2013–2014

The 60 m<sup>3</sup> instability that occurred on this slope in January 2012 was classified as a toppling according to the morphology of the original block and the observable rupture scar (i.e. J1 discontinuity set) after the failure (Figs. 5c and 9a). This main failure was accompanied by some minor rockfall instabilities of nearby rock blocks (Fig. 6a). The second registered instability occurred between June 2013 and July 2014 and also consisted of a toppling of a metastable rock block controlled by the set J1 (Figs. 5d and 6b). Neither an earthquake nor rainfall was recognized in the previous days to these events, and therefore, the trigger of these events is attributed to the natural dynamics of the rock spreading. Actually, it is well known that despite the low displacement rate of rock spreadings, they can induce hazardous, collateral, faster landslides as topples and rockfalls, mainly on edges of the mobilized rock mass that are not confined laterally (Delgado et al. 2011, Gutiérrez, et al. 2012, Mantovani, et al. 2013). Additionally, some authors suggest that rockfalls can potentially be considered as precursory behaviour prior to a larger slope failure or landslide (e.g. Rosser et al. 2007, Royán, et al. 2014). In this case of study, it can be seen that the gypsiferous rock block destabilized during the January

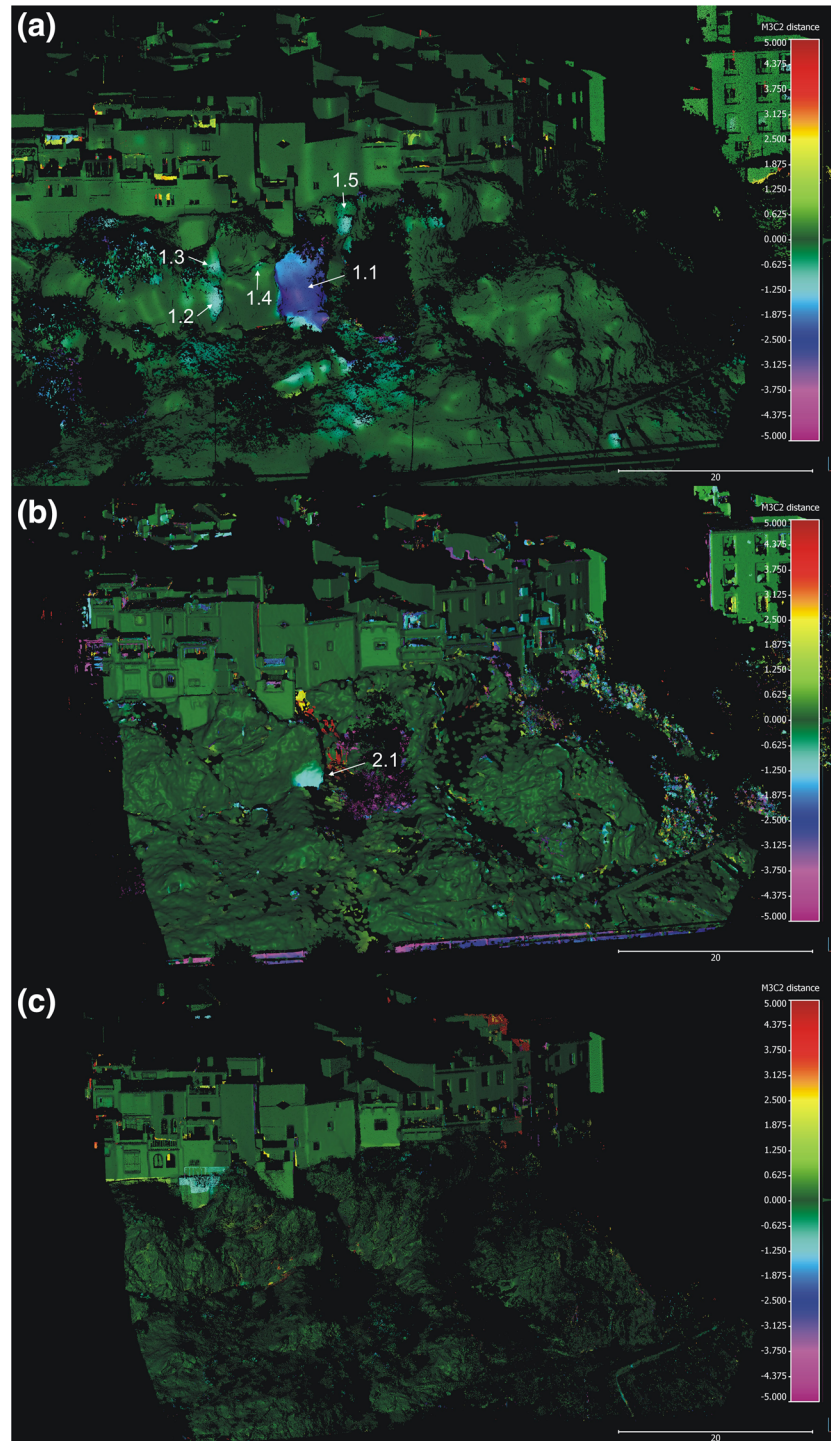
Some corrective measures were taken on the slope in 2016 that substantially modified the comparison point cloud, as mentioned before. Therefore, no changes have been recognized in the third processing (i.e. 2014–2016).

The changes not labelled in Fig. 6 are associated with outliers that generate isolated changes, man-made modifications (e.g. the anchored reinforced concrete capping beam built between 2014

**Fig. 6** Comparison of LiDAR models showing large-scale changes corresponding to **a** February 2011 vs. August 2012, **b** August 2012 vs. July 2014 and **c** July 2014 vs. January 2016. The labels indicate the rockfall events detected for each period. Note that the two last images only cover the easternmost sector of the slope since the 2014 3DPC was only acquired for the study of the buildings placed on this sector

periods 2011–2012 and 2011–2014 are near 15 cm, being slightly higher in the upper part of the slope and the lower part of the buildings (Figs. 3, 6 and 7). Notice that, as the inclinometer S-1 is placed on the back of the rock block delimited by the main earth fissure (Figs. 1 and 3), its displacements are lower than those measured by means of TLS data on the slope face and the

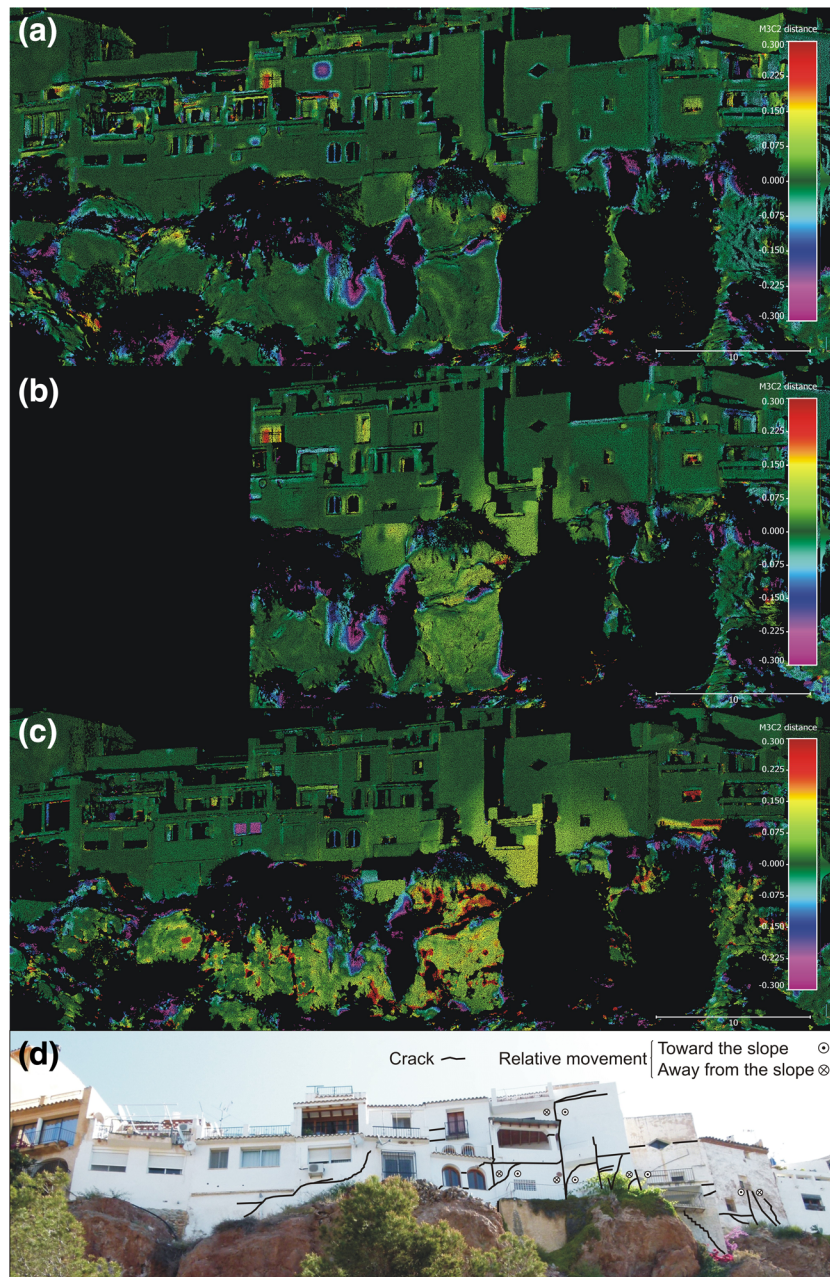
**Fig. 7** Comparison of LiDAR models showing small-scale changes corresponding to **a** February 2011 vs. August 2012, **b** February 2011 vs. July 2014 and **c** February 2011 vs. January 2016. Note that the colour scale has been adjusted to small magnitude changes. **d** Observed cracks in the façades of the buildings placed on the slope and *symbols* indicative of the relative sense of motion

TLS information (Fig. 7) also agrees the distribution of the observed damage. The TLS-derived displacement plot shows maximum displacement values up to 15 cm on the line of sight between February 2012 and January 2016 concentrated on the lower balcony of the buildings classified as “Partial collapse” in

agreement with the forensic analysis (Fig. 10). These displacements gradually reduce towards the east, the west and from bottom to top of the buildings and perfectly match the area defined by the cracks mapped on the building façades (Fig. 10). Additionally, the typical distribution of cracks (Fig. 7) of the south façades of the buildings (i.e. dipping towards east and west on both extremes, respectively) indicates that the central part of

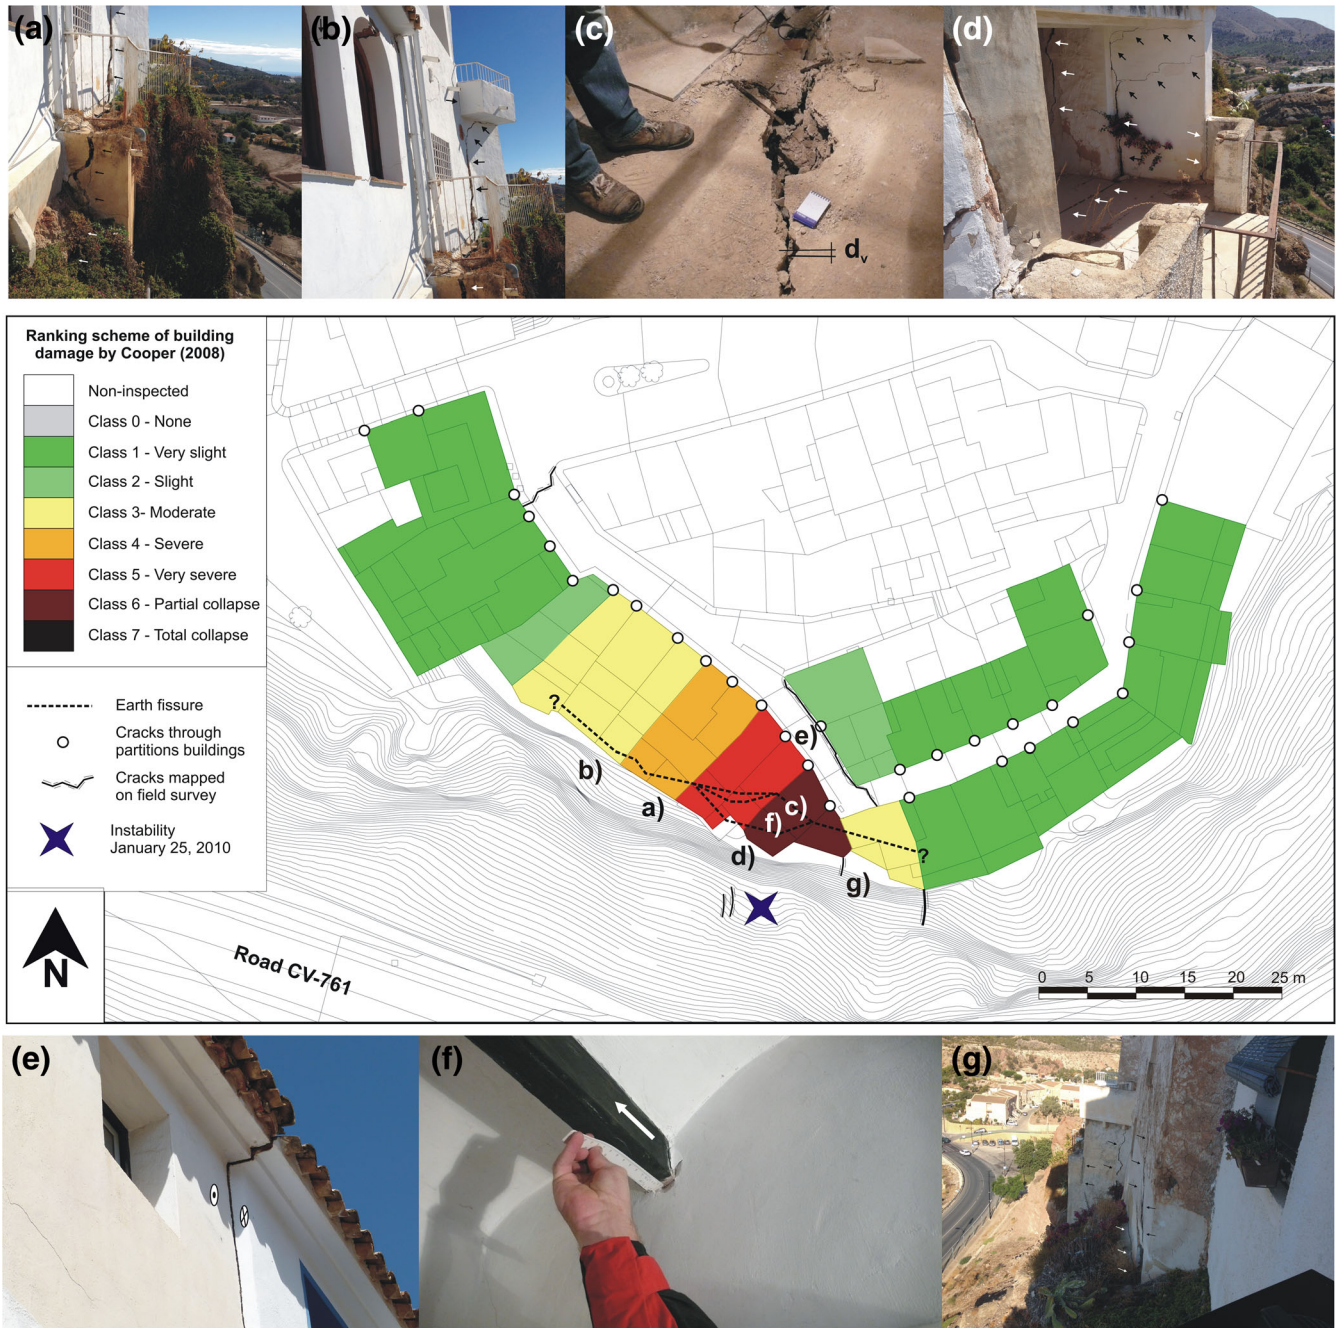
The buildings located on the top of the slope present important damage mainly consisting of cracks and fissures that were documented, described and mapped during fieldwork. Furthermore, some of the buildings placed on the crown of the slope present tilting since their load-bearing walls are partially founded on the most active rock block and partially founded on the inner less active rock block. The differential vertical displacements between both rock blocks cause the tilt of the building.

Complementarily, the damage of the buildings was ranked according to Cooper's (2008) building damage recording scheme, based on distribution and severity of the damage. The building structures of these properties are mainly composed of load-bearing masonry walls and wood joists, which are quite sensitive to vertical and horizontal differential displacements due to their rigidity (Burland and Wroth 1975).

Field works have allowed the recognition of important structural damage (class 3 to class 6) on buildings, mainly concentrated near the slope face, decreasing as we move away from the cliff. In fact, most of the damaged buildings do not exhibit any damage or lesser damage on the north façades, as the severe damage is mainly concentrated on the portion of the buildings founded on the main unstable rock block (Figs. 7d and 10). Furthermore, some minor damage (class 1 to class 2 in Fig. 10) have been observed as incipient fissures on the façades of some buildings, as well as on the rigid pavement of the street.

The developed forensic analysis agrees the previous results, showing that there is a clear zonation of the damage affecting the buildings (Figs. 7d and 10). The further away from the slope, the lower the damage, since most of the cracks affecting the buildings are concentrated near the slope face. In fact, some of the most damaged buildings located on the front of the slope crown even show very slight damage on their north façade. The explanation for this is that some buildings are partially founded on the unstable massive gypsiferous rock blocks (delimited by the

**Fig. 10** Damage observed in the buildings placed in the crown of the studied slope. Note that the level of damage of the buildings has been ranked according to Cooper's (2008) classification. The main damage observed on the buildings placed on the top of the slope consists of **a** long persistence and wide-aperture cracks (Fig. 10a–g) affecting the walls and the floor of the buildings, **b** 45° cracks on the lateral walls of the buildings dipping away from the slope, **c** longitudinal displacements of the wood joists towards the slope (Fig. 10e, f) and **d** relative displacement (tilt) of the north façade towards the slope face (Fig. 10e)

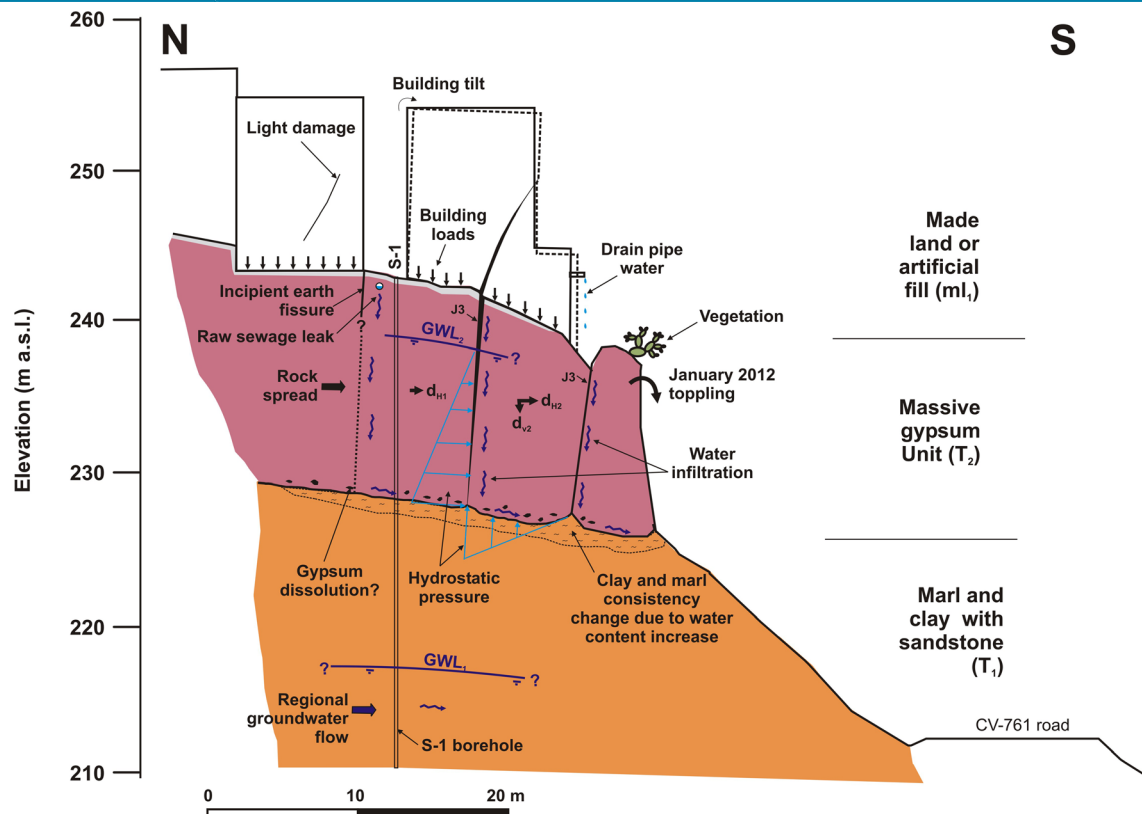
recognized earth fissure) and the other part of the building is placed on a metastable block with a lower activity (Fig. 11).

Groundwater existing on the slope could play a key role on the kinematics of this phenomenon due both to chemical and physical components. As previously explained, the groundwater present on subunit T<sub>1</sub> seems to have a regional input. However, the perched groundwater of subunit T<sub>2</sub> presents a greater local influence of the surface runoff that is directly poured over the slope and the discharge from septic tanks and the sewers. This water can infiltrate through the discontinuities of the gypsiferous massif (subunit T<sub>2</sub>) to the lower impervious layers of clay (subunit T<sub>1</sub>) partially filling the existing tension cracks.

The groundwater that flows through the gypsum-clay/marl contact can dissolve the bottom of the gypsum blocks up to saturation, eroding and causing a gradual loss of strength that can contribute to the observed subsidence as described by Gutiérrez-Santolalla et al. (2012). Complementarily, this groundwater can saturate the underlying clay and marls modifying its consistence state and enabling their deformation and the consequent subsidence of the overlaying gypsum rock mass as previously described. Groundwater can also cause other well-known

**Fig. 11** N-S cross-section of the studied slope based on the information provided by the different techniques. GW<sub>L2</sub>: groundwater level on subunit T<sub>2</sub>; GW<sub>L1</sub>: groundwater level on subunit T<sub>1</sub>; d<sub>H1</sub>, d<sub>H2</sub> and d<sub>V2</sub> are the horizontal and vertical displacements of the rock blocks, being d<sub>V2</sub> < d<sub>H1</sub> < d<sub>H2</sub>

Figure 11 shows an interpretative cross-section of the rock spread summarizing the different integrated aspects considered in this work, the kinematics, the mechanisms and the conditioning factors as previously described.

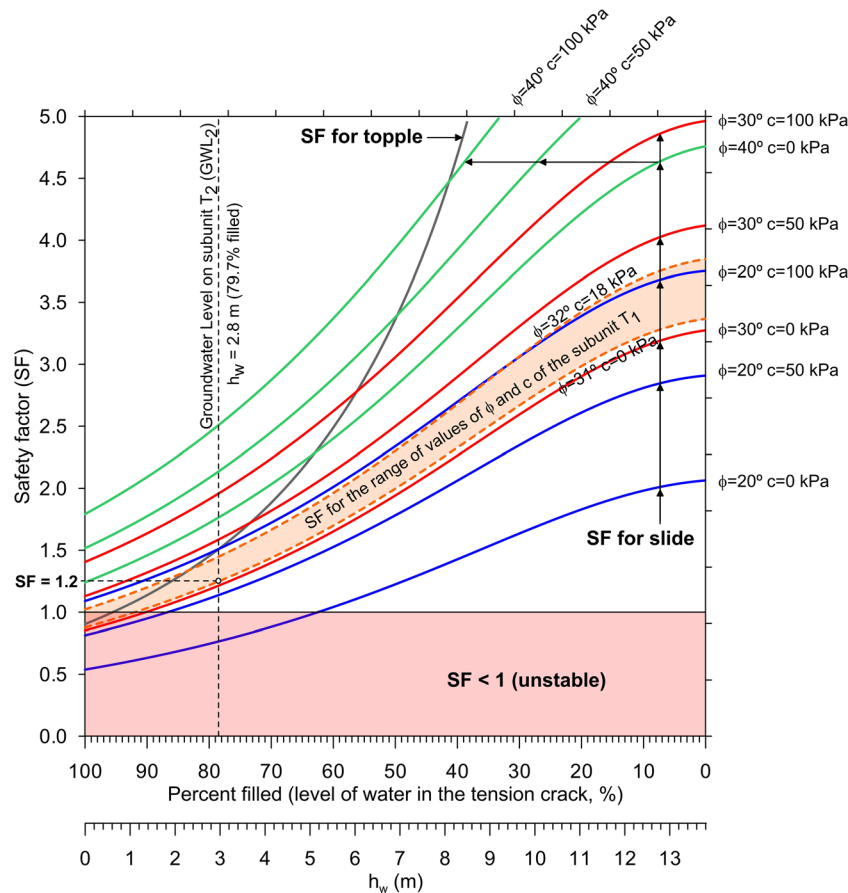
**Fig. 13** Summary of the values of the safety factors of the slope obtained from the performed sensitivity analysis considering toppling and planar failure modes

Since in this case of study geotechnical properties pose some uncertainties in the simulation, each significant parameter (i.e. the friction angle, the cohesion and the percent filled of the tension crack) has been varied systematically over its maximum credible range in order to determine its influence upon the factor of safety. The other parameters have remained constant. The results of the analysis are shown in Fig. 13.

The plot shows that the SF for toppling increases very quick when groundwater level falls and, as it is well known, does not depend on the shear strength on the sliding plane. Furthermore, SF only reaches values lower than 1 when more than 95% of the tension crack is filled with groundwater (i.e. when  $h_w$  is lower than 0.6 m).

For planar sliding, SF considerably increases with the friction angle and the cohesion, although the groundwater level exerts a greater influence. Assuming that the sliding of the block occurs along a failure surface involving the subunit T<sub>1</sub> and considering the upper and lower bound values of friction angle ( $\phi$  from 31 to 32°) and cohesion ( $c$  from 0 to 18 kPa) (Table 1), we can calculate the envelope of the SF (plotted in light orange in Fig. 13). These values show that SF is less than 1 for  $h_w$  lengths lower than 1.1 m (i.e. more than 92% of the crack filled). Thus, the results indicate that when the perched groundwater level (GWL<sub>2</sub>) increases, both the toppling and the sliding SF reduce. However, SF reaches values lower than 1 (unstable) firstly for planar sliding before doing so for toppling failure. Additionally, for  $h_w$  values up to 2.8 m (79.7% of the crack filled; Fig. 13), as the one recorded in borehole S-2', the safety factor is 1.2 for planar failure and 1.4 for topple. When the groundwater level falls under the contact between subunits T<sub>1</sub> and T<sub>2</sub>, SF becomes infinity for toppling and 3.4 for planar sliding. Therefore, the stability analysis supports the sliding of rock blocks caused by ground water pressure as the main instability mechanism, although when high percentages of the tension crack are filled by groundwater (more than 95%), the blocks can also be affected by both toppling and sliding processes.
